# State of the Cienega Watershed

December 1, 2023

# Cienega Watershed

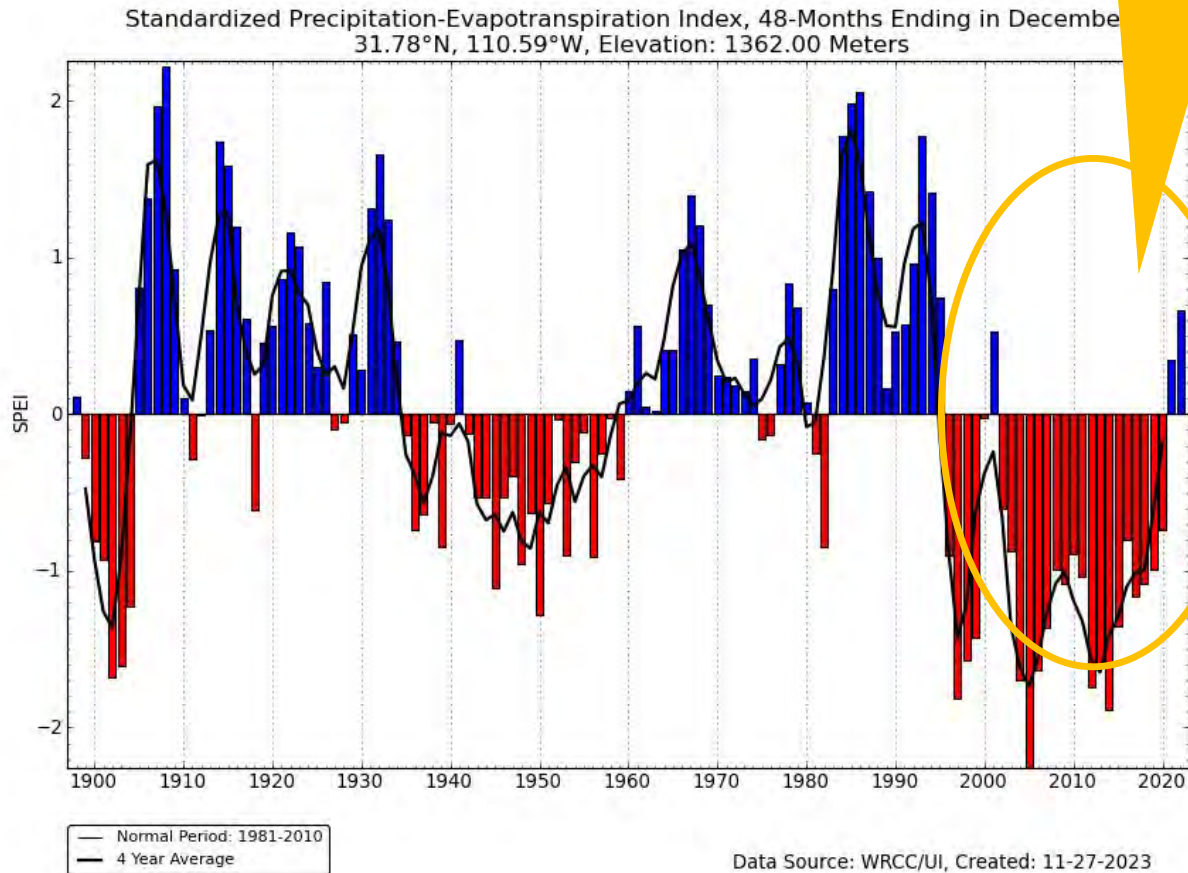
48-month SPEI – 4 yr. average

We are in a drought
